CONFIDENTIAL: Technical Report

Project FPD0006 Fire test Utilising the general principals of ASFP TGD19 (Nov 2017). Assessing a Tenmat Ventilertat Brandstop Eaves Barrier with mesh spark arrester on non-fire side of the barrier	
Report Date	4/12/2020
Author	Ian W. Hainsworth
Circulation	DR, MD, KC, CC, GB, PD

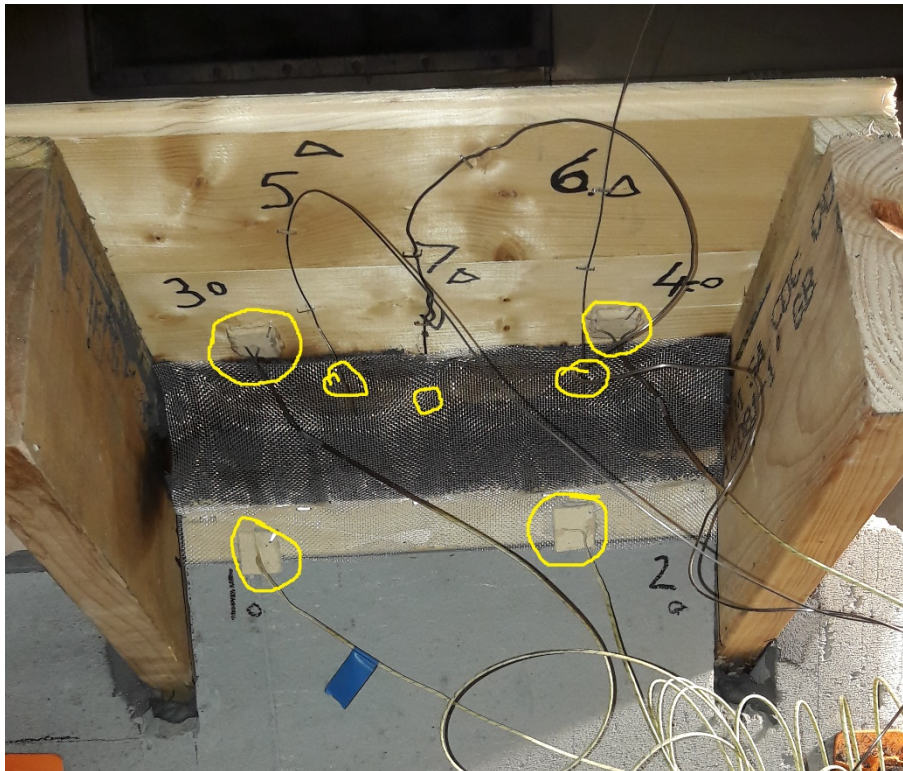
1. Surface – on rear of the wall plate left hand side, quarter of the distance in.
2. Surface – on rear of the wall plate right hand side, quarter of the distance in.
3. Surface – on underside of the roof boards left hand side, quarter of the distance in.
4. Surface – on underside of the roof boards right hand side, quarter of the distance in.
5. Suspended in the air cavity non-fire side, left hand side, quarter of the distance in and 25mm back from the mesh

6. Suspended in the air cavity non-fire side, left hand side, quarter of the distance in and 25mm back from the mesh
7. Suspended in the air cavity fire side, centrally positioned over the intumescent material, 10mm back from the fire side edge.
8. Furnace thermocouple

Thermocouples shown in the picture below, indicated by the yellow circles.

One extra suspended external thermocouple (No 7) placed at the upper central section of the barrier pad to monitor the temperature at the top of the intumescent it was placed 10mm from the fire side of the material, this thermocouple is additional to the requirements of the test standard, and as such will play no part in the integrity or insulation results expressed in the findings of this test report.

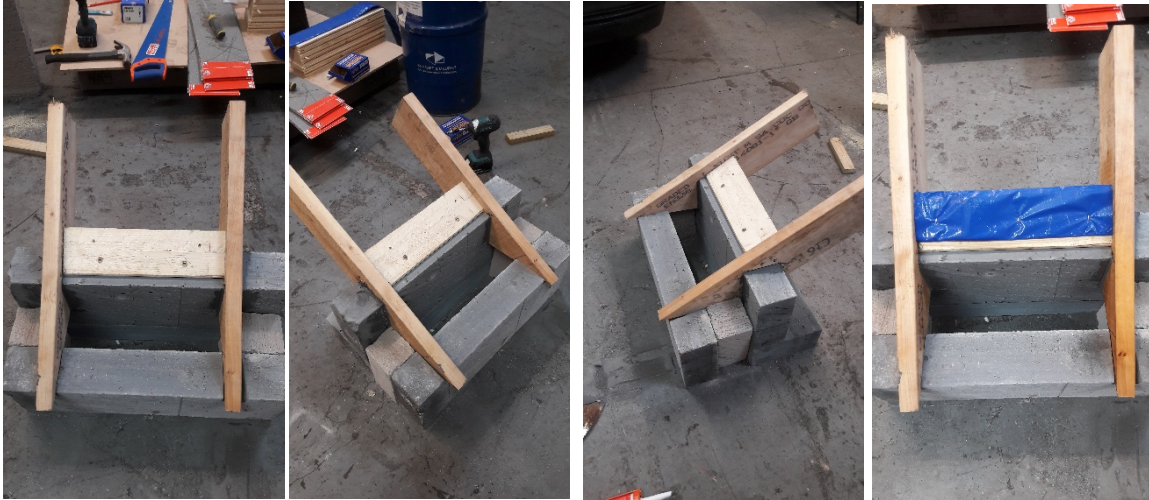
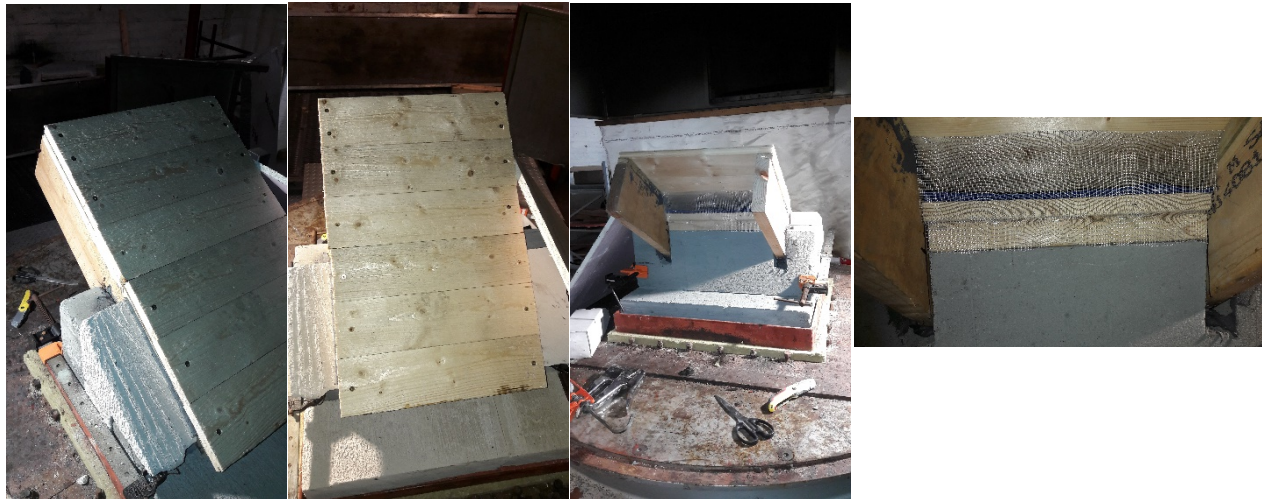
Images of the sample pre test

A cavity size at the eaves of the roof of 50mm high x 450mm wide incorporating a sample of eaves barrier with a remaining air gap of 46mm from the top of the barrier on the wall plate to the underside of the T&G boarding, on the unexposed side of the Ventilert Brandstop fire barrier, an aluminium spark arresting mesh was fitted to the non-fire side of the wall plate, this mesh measured 150mm high x 450mm wide, stapled into place using 10mm galvanised steel staples

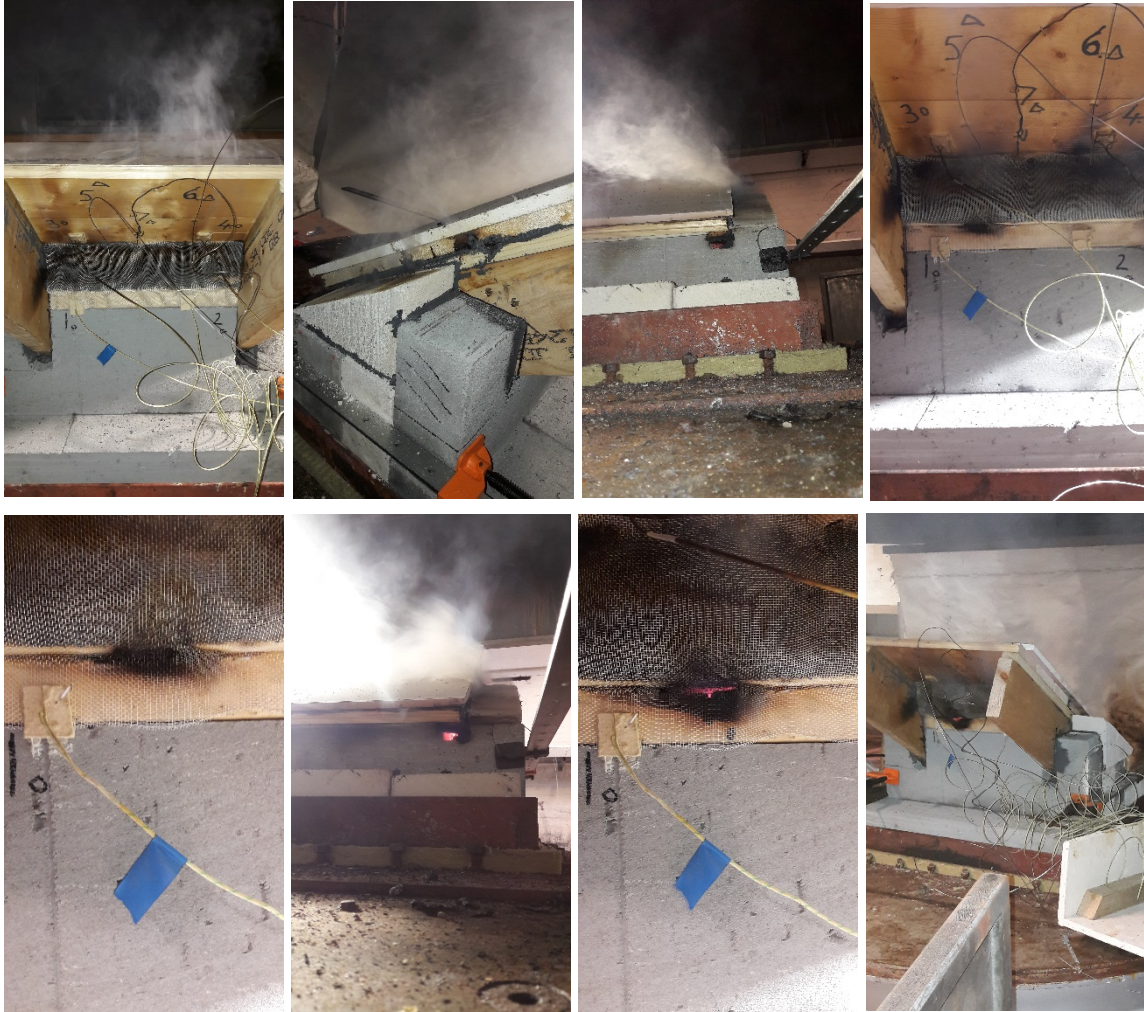
Images from the test

- 00 The test commences.
Plastic cover melts and shrinks away 15 seconds – FF107 starts to react 50 seconds
- 01 FF102 intumescent material starting to react to a greater extent within the assembly, char being trapped by the mesh effectively closing off the openings in the mesh.

- 02 Fully closed off visually, 1minute 50 seconds
- 03 Slight smoke from the test rig
- 04 No Change
- 05 No Change
- 06 No Change
- 07 No Change
- 08 No Change

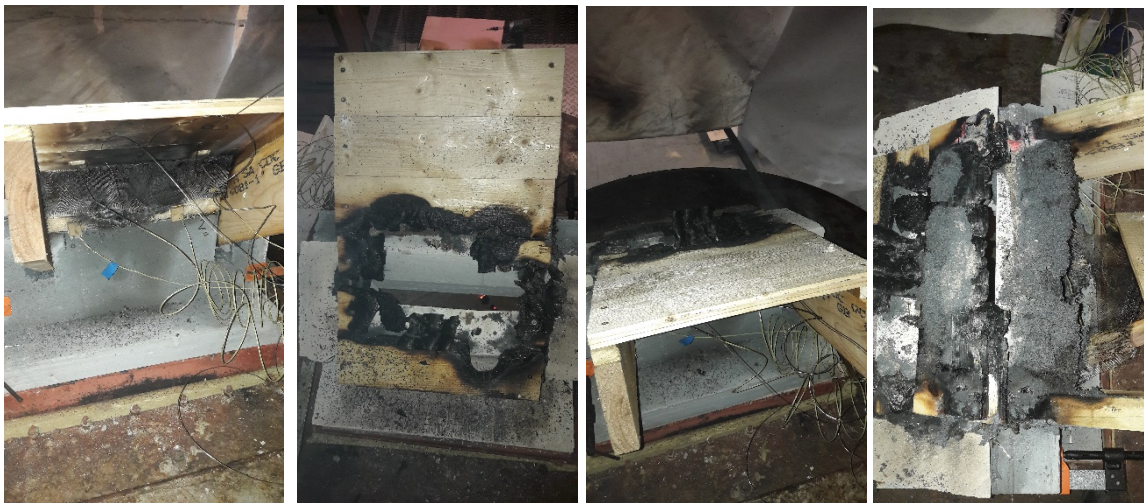
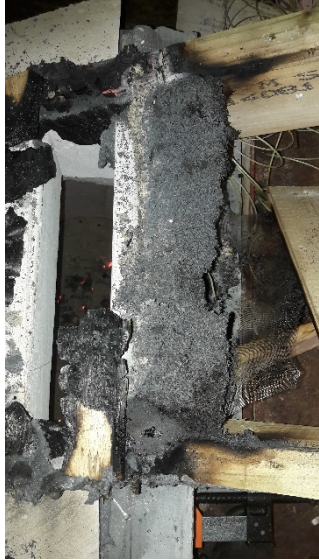
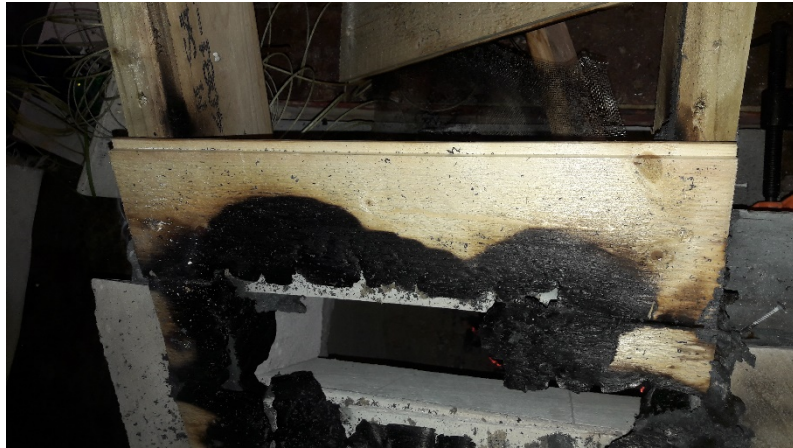
Test Sample Deconstruction

The test was run for 64 minutes at which time the timber wall plate under the barrier lost integrity and active flaming was observed.

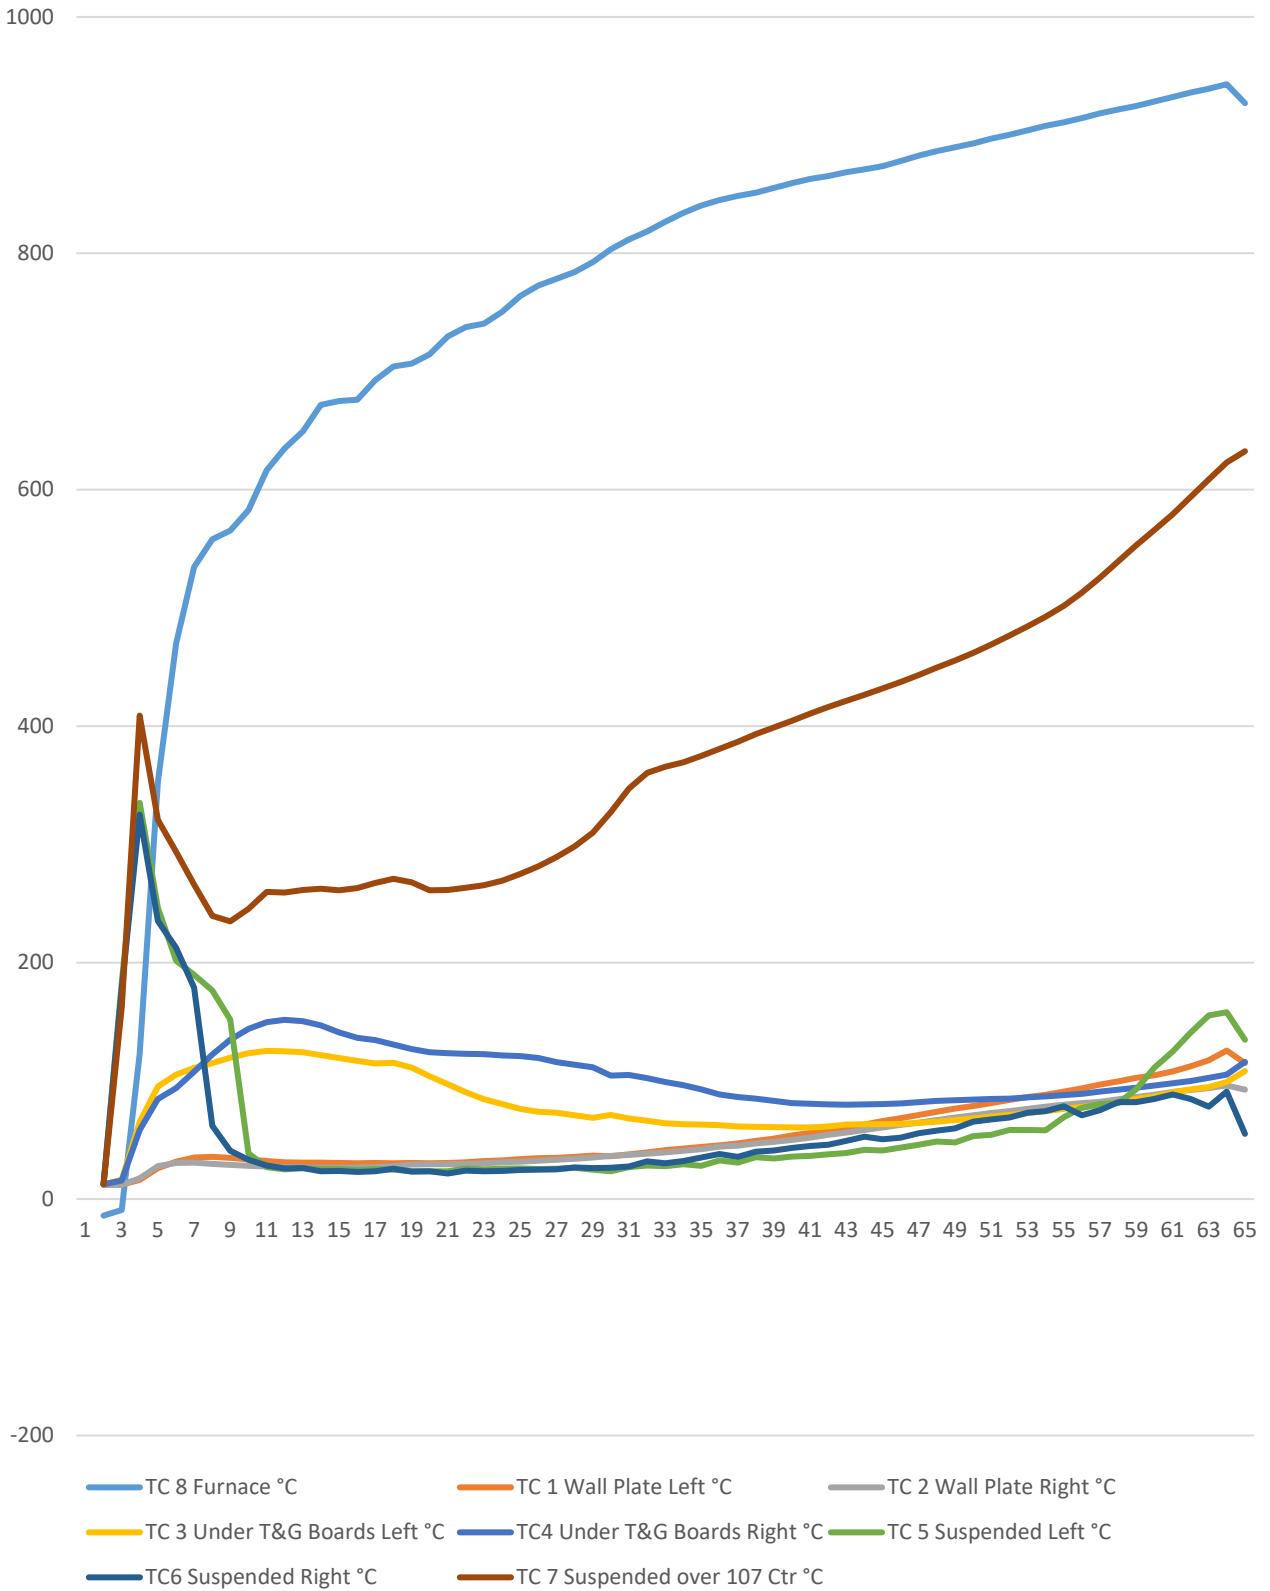
FlameGuard Test 4/12/2020

Temperature Readings Taken During the Test

- Closure time observed 1minute 50 seconds
- Thermocouple readings below 192 degrees - 4 minute 39 seconds
